ATTACHMENT 5 Color Photographs

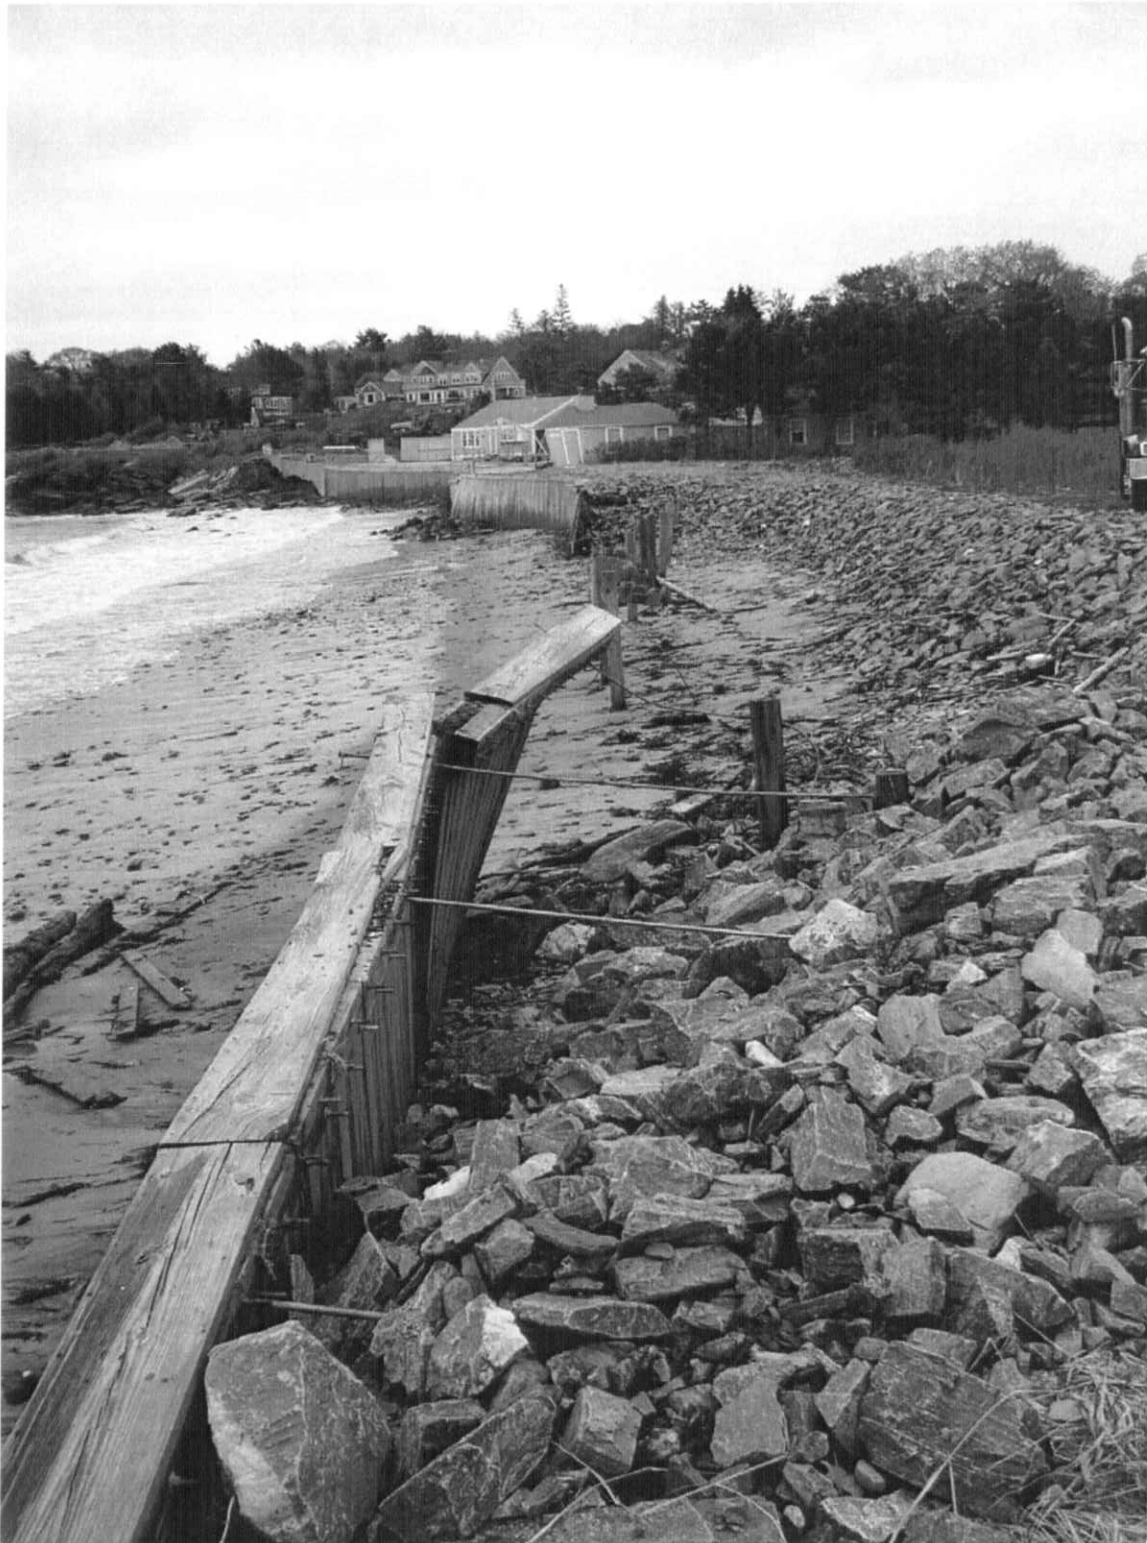
This picture is from the minutes of the October 30, 2009, meeting involving the applicant and representatives of the Department, Maine Geological Survey, and U.S. Army Corps of Engineers. The picture shows the breach in the vertical bulkhead at Mrs. Stone's property. The beach club can be seen in the background. The corner of Mrs. Stone's residence can be seen on the right side of the photo.

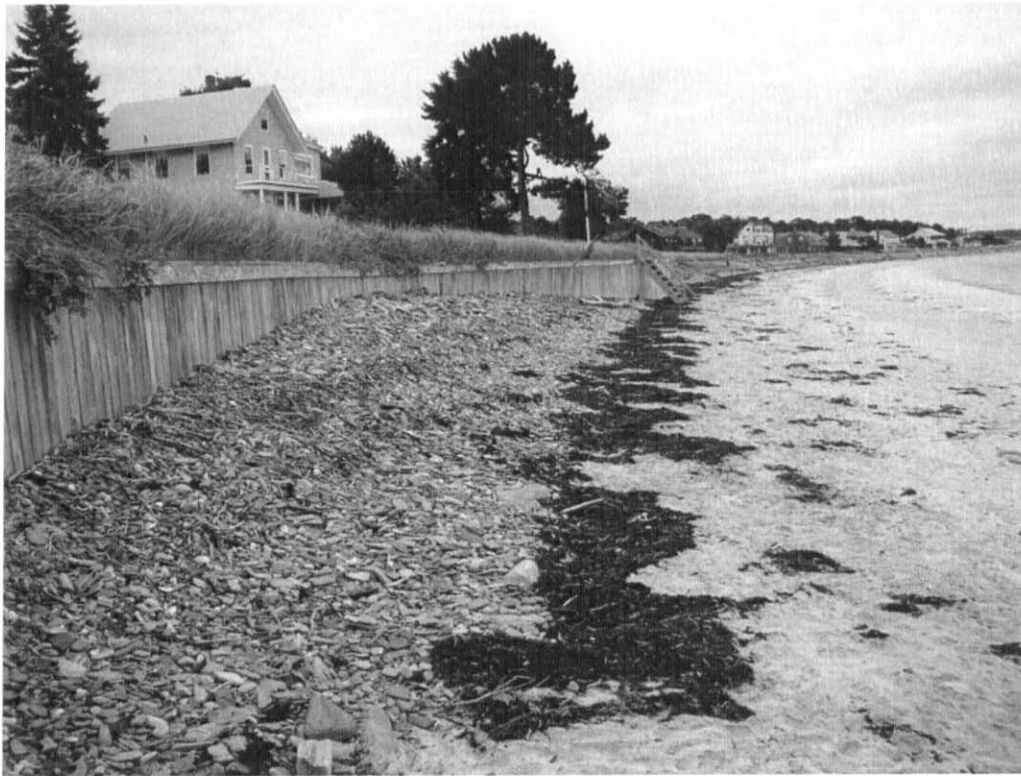
April 07 storm damage. Looking across Stone property towards the Prouts Neck Beach Club.

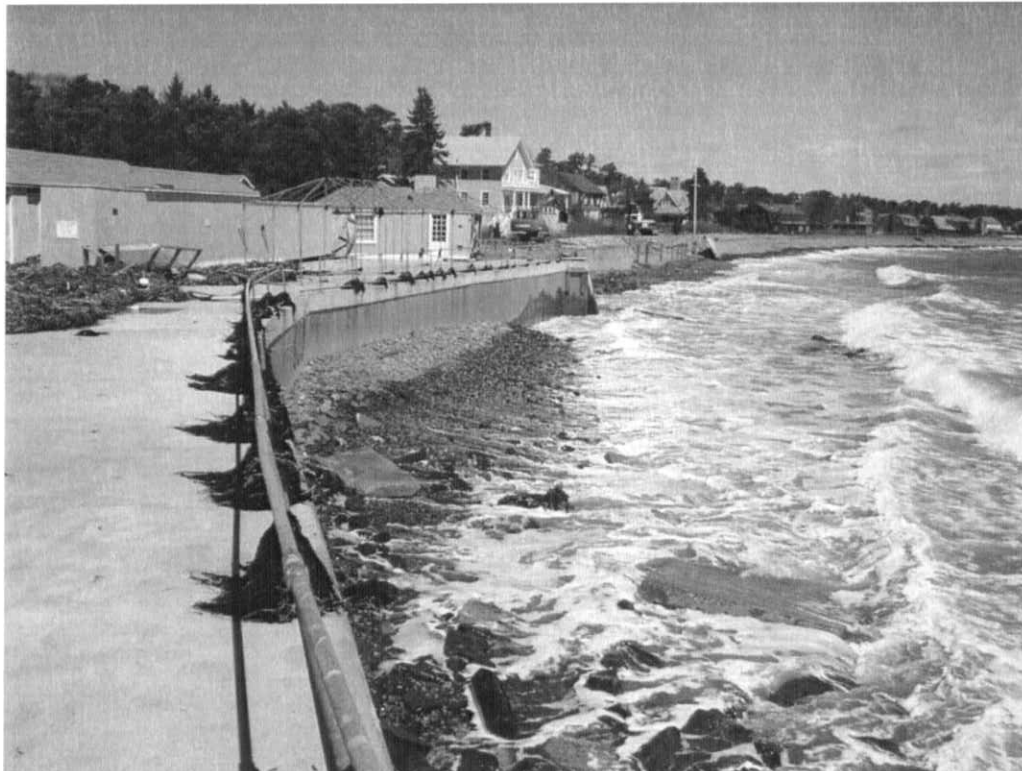
Pre-storm damage condition of Stone property above. Note 'bump' in horizontal wall alignment. Contrast with April 2007 damage below. Note that the Prouts Neck Beach Club wall was replaced in 2006.

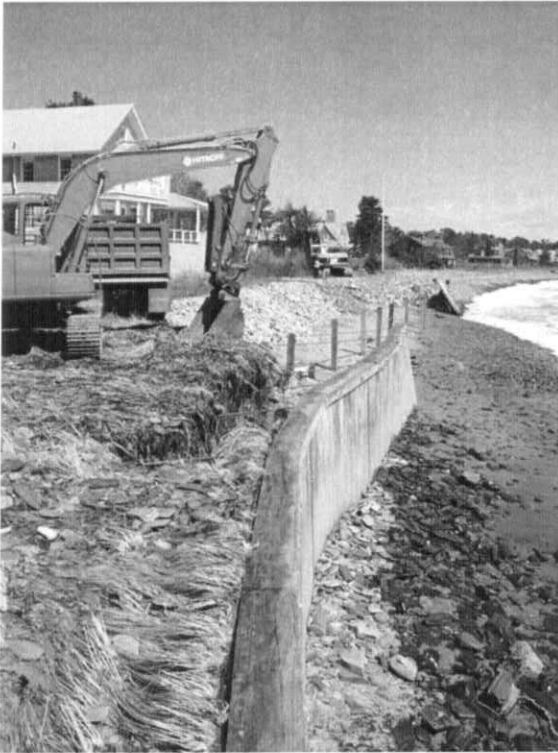
Close up of April 2007 storm damage.

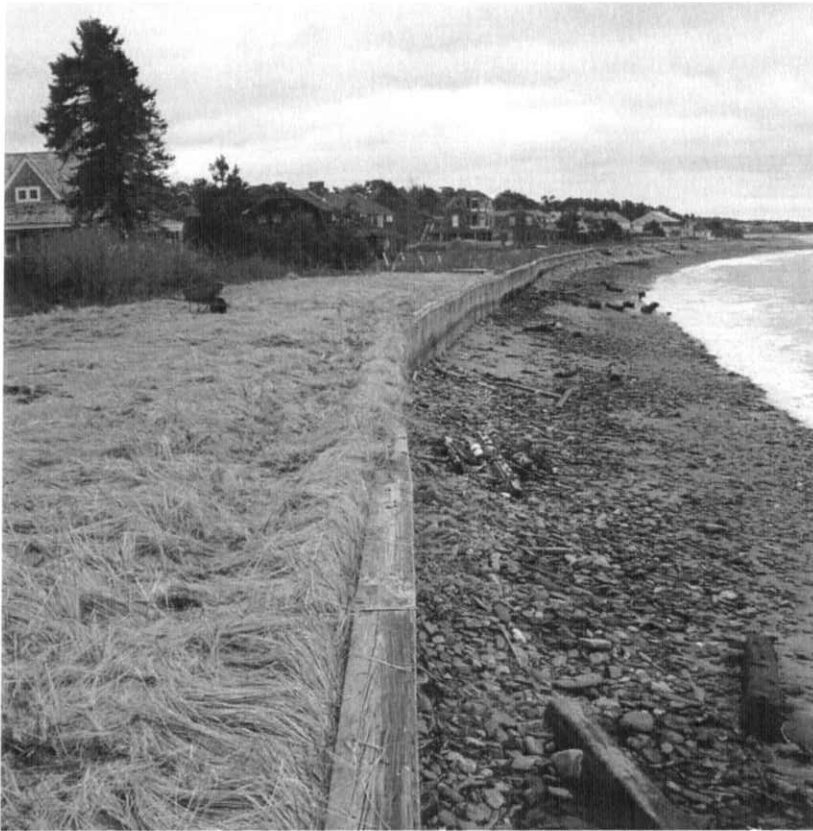
Replacement of Dune Grass on Rockefeller Property. Kohlberg property beyond.
